Interpreting Refractory Wear in Rotary Kilns

Interpreting Refractory Wear in Rotary Kilns cont.

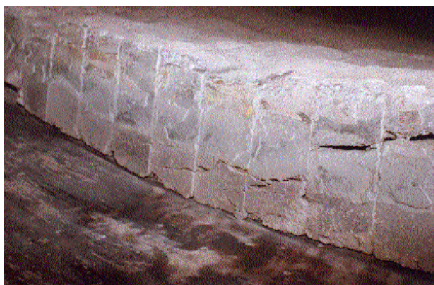
Figure one: Ring of brick adjacent to a fallen lining. Note the propagation of cracking from the cold end out to the hot face.

Figure one (1) shows a basic brick lining that was installed loosely. Brick fell out of this lining within about six weeks of operation. Note the propagation of the cracking from the cold end toward the hot

face. Any movement present within the brick ring causes brick to point load and fracture. Deep spalling can be an indication of a lining that was installed without sufficient tightness.

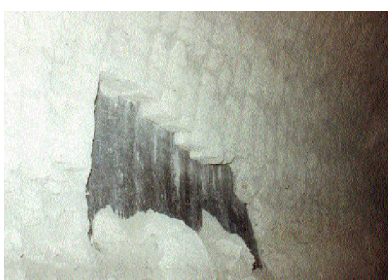
Figure two: Brick loss in a "trough" formation due to a problem with alignment.

Figure two (2) shows brickwork in a lining that has exhibited crushing in a "trough" pattern. This problem was caused by the misalignment of the kiln at the #2 tire. A thorough ovality and alignment study may be necessary to completely diagnose the problem. *Cont. on backside*

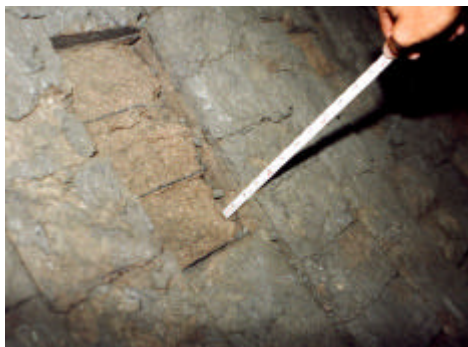
Figure three: Liquid phase attack caused spalling in this magnesite-spinel lining.

One such example is liquid phase attack (see the RESCO LINE™ Volume 2, number 1). Figure three (3) shows the basic brick lining in a cement kiln that

has absorbed liquids from an overheated clinker. Figure four (4) shows the reacted hot face in a cut section. The reacted area exhibits cracking beneath the shrunken hot face zone and "slabs" off. Chemical analysis of the hot face area will confirm attack from a liquid slag or melt. In the case of clinker liquid phase attack, this will be indicated by enrichment of lime and silica in the refractory hot face.

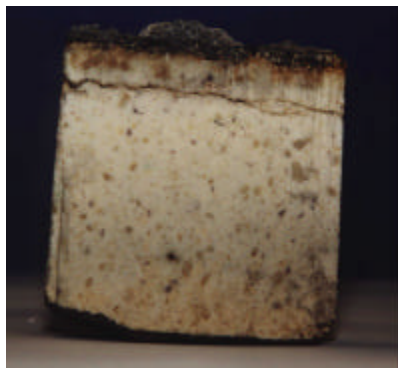
Figure four: Cut section of the brick shows cracking below the hot face portion where the liquid phase has penetrated.

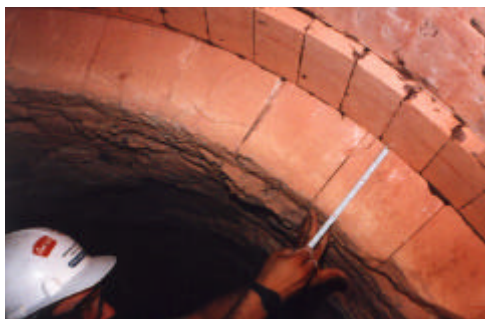
Figure five: Expansive alkali cracking in high alumina brick. Note the corners have cracked to relieve the pressure.

relieve the stress caused by the increase in size. Expansive cracking in brickwork can often be observed as diagonal cracking at hot face brick joints (see figure 5). If alkali cracking is suspected, an X-ray diffraction analysis of the used brick is useful in confirming the nature of the expansive alkali phase.
